Error Sequence^{1,2} and the Loss of 88 Souls on Alaska Airline's Flight 261

Thomas C. (Tom) Mawhinney

This is a *Working Paper* presented at meetings of **Behavior Safety Now**, September 27, 2007 in Kansas City, MO.

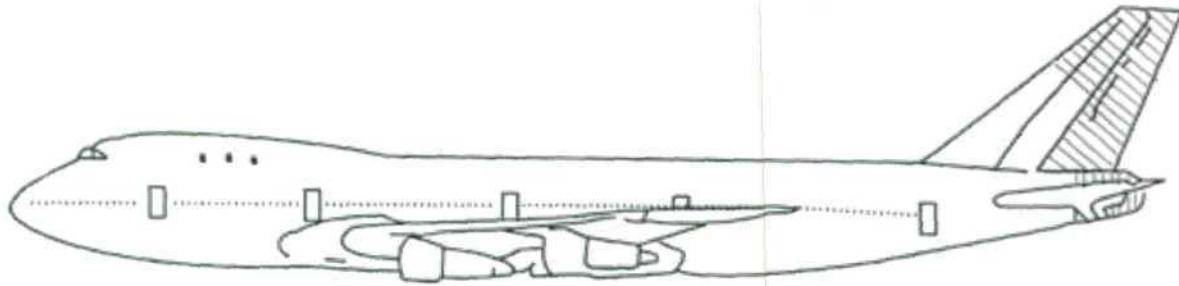
If this had resulted from a flaw in the design, materials or the way they were put together in the manufacturing process and the flaw(s) had been discovered by the FAA prior to manufacture, the Boeing 747 would not have been given an air worthiness certification by the FAA. In this case, however, loss of portions of the rudder, vertical stabilizer and some elevator function, that rendered the aircraft uncontrollable, were not attributable to faults in these systems per se. But, importantly, loss of control function by each of these lost and/or damaged control surfaces was due to an explosive decompression. The explosive decompression was, in turn, caused by an improper repair to the aft airtight pressure bulkhead damaged when a tail strike occurred during a landing on June 2, 1978 (see Figures 3 and 4).

Figure 3. Damaged area of the empennage indicate by line shading.

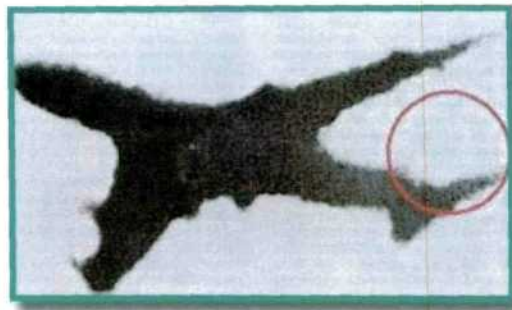
Figure 4. Actual (although poor) image of the damaged aircraft in flight.

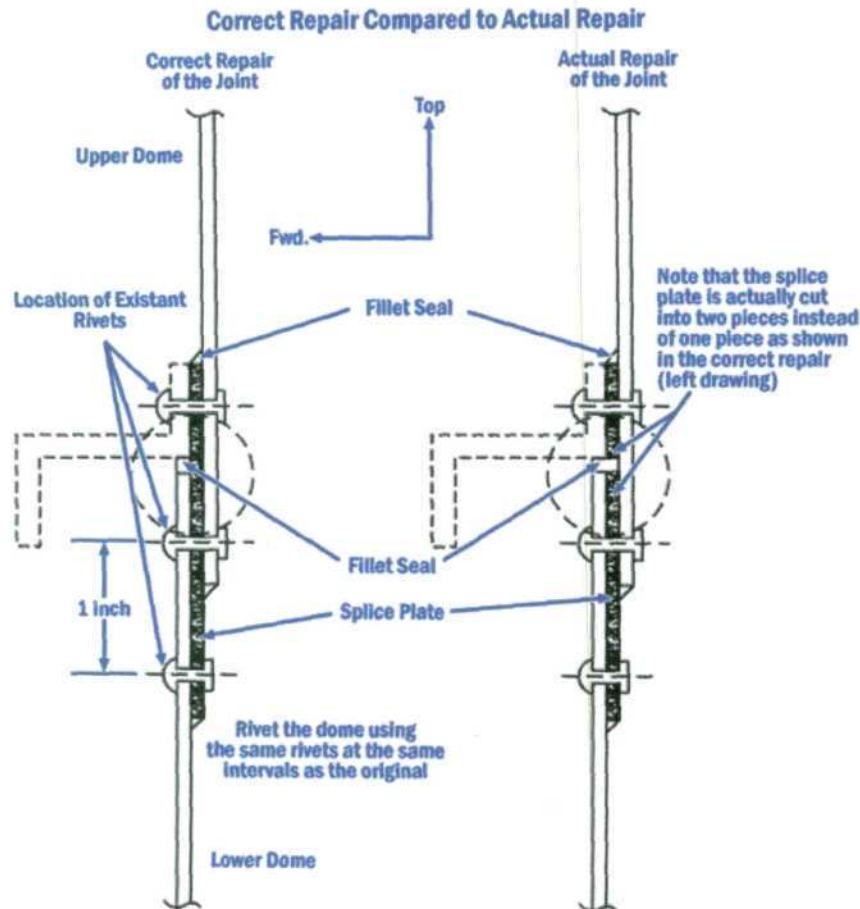
Thus, the fate of Japan Airlines Flight 123 and its 520 passengers in 1985 had been sealed seven years earlier when the faulty repairs were made to the aft airtight pressure bulkhead. The correct and actual (incorrect) repair methods are depicted in Diagram 2. Here a connection is revealed between two human errors and two functional areas within one airline company: a.) a pilot error and b.) a maintenance mechanic's (s') repair error.

Diagram 2. Correct and incorrect methods of airtight metal surface repairs.

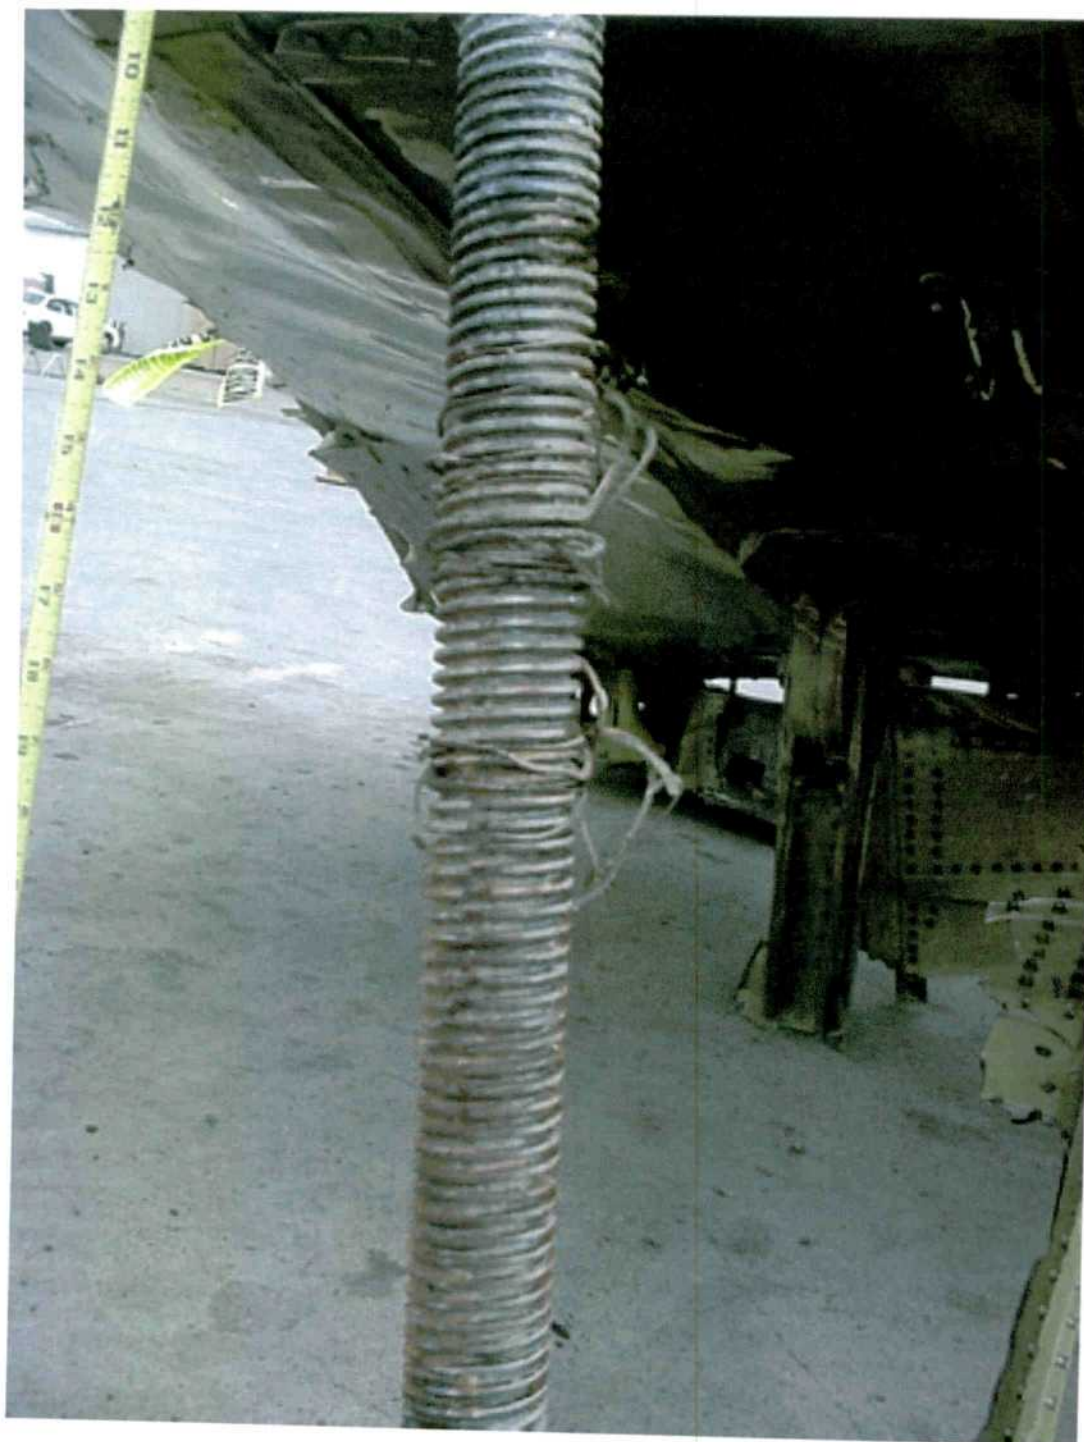
Figure 12. The acme screw immediately after it was brought to shore. Source: Figure 12b NTSB 2002, p. 60.

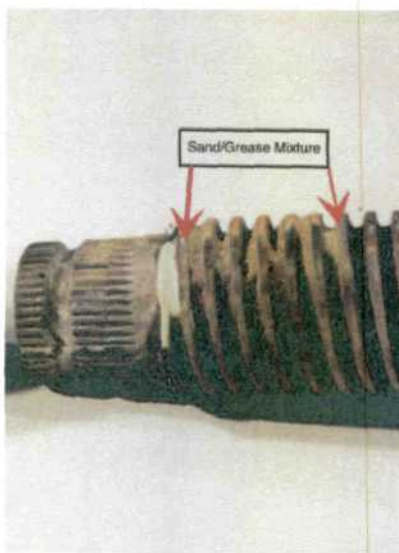
On-scene visual and tactile inspections by Safety Board metallurgists of the acme screw's threaded areas [of the accident aircraft] found no evidence of grease in any condition, either semi-fluid (that is, fresh) or solid/dry (that is, old or degraded), or other lubricants in the central "working region" of the screw threads.¹²⁹ Laboratory examinations found small flakes of dried and hardened grease attached to some of the thread remnants in this region. The acme screw's lower threads (which are outside of the working region) were found partially packed with a mixture consistent with sand and grease. (Figure 14 [Figure 13 in this paper] shows the sand/grease mixture packed between the acme screw's lower threads.) Parts of the acme screw's upper six to eight threads had an oily sheen, and small deposits of greaselike material were found between the threads. (NTSB, 2002, p. 69)

Figure 13. A photograph of the sand/grease mixture packed between the acme screw's lower threads. Source: NTSB (2002, Figure 14, p. 69)

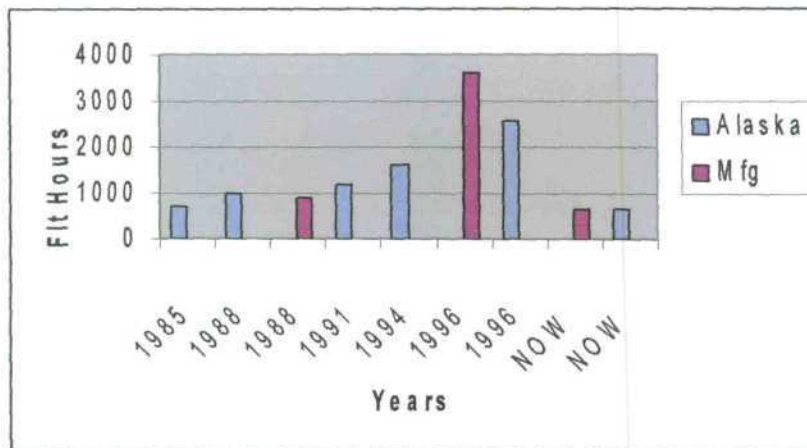
In spite of this history it is clear that Alaska Airlines, manufacturers and the FAA were involved in lubrication interval extensions, see Figure 14.

Figure 14. History of Lubrication Interval Extensions by Alaska Airlines and manufacturer.
Data Source: NTSB (2002)

Contributing to the accident were Alaska Airlines' extended lubrication interval and the Federal Aviation Administration's (FAA) approval of that extension, which increased the likelihood that a missed or inadequate lubrication would result in excessive wear of the acme nut threads, and Alaska Airlines' extended end play check interval and the FAA's approval of that extension, which allowed the excessive wear of the acme nut threads to progress to failure without the opportunity for detection. Also contributing to the accident was the absence on the McDonnell Douglas MD-80 of a fail-safe mechanism to prevent the catastrophic effects of total acme nut thread loss. (NTSB, 2002, p. xii)

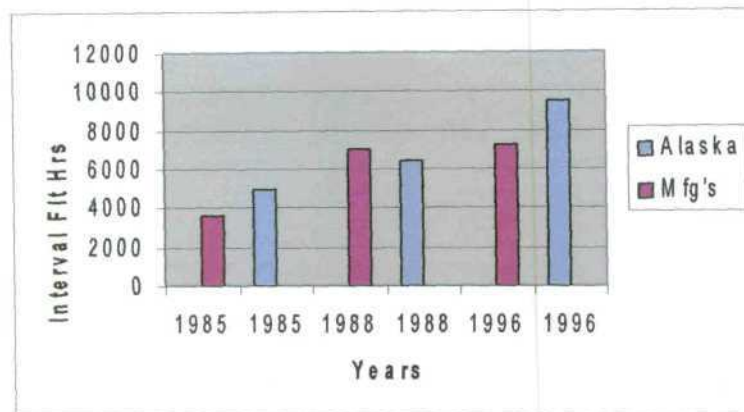
According to the NTSB (2002) accident report, at the time of the accident Alaska Airlines' end play check interval was conducted "[e]very other C check 30 months (About 9,550 flight hours)" (p. 49) while the manufacturer's interval was "[e]very other C check (7,200 flight hours or 30 months, whichever comes first)" (p. 48). So by either standard (Alaska's or the manufacturer's) there could be up to two and a half years between end play checks while Alaska Airlines' maximum hours was about a third longer than the manufacturer's, see Figure 15.

Figure 15. History of End Play Check Interval Extensions by Alaska Airlines and manufacturer. Data Source: NTSB (2002).

In light of what has been learned in this investigation, it is now apparent that the Manufacturer's previously recommended end play check intervals of 7,000 or 7,200 flight hours were not adequate.²⁵⁴ Nonetheless, the Safety Board notes that if Alaska Airlines had not extended its end play check interval to beyond the recommended interval, the airplane would have been required to undergo an end play check at least 1,800 to 2,000 flight hours before the accident, and the excessive end play could have been identified at that time. (NTSB, 2002, p. 152-153)
